STRUCTURAL ASSESMENT OF EXISTING SUSPENSION BRIDGE BETWEEN CAMEROON AND NIGERIA

M.B. Petri

Kedmor Engineers LTD, Israel

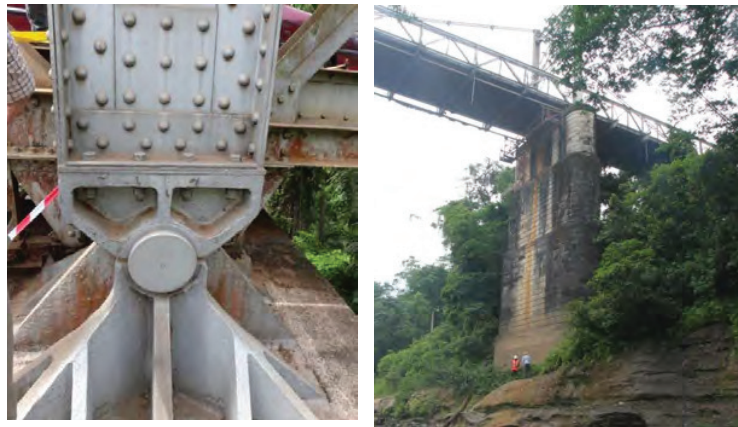
The Bearings are connected with bolts to columns. The bearing longitudinal release is critical for the proper behaviour of the bridge mainly to withstand the effect of temperature on the bridge and participate in the flexibility of the structure. The bearings of the main span are sliding in the longitudinal direction with steel stoppers and the enable rotation. The bearings at the external spans (1,3,4) are sliding pins. They are sliding only in the longitudinal direction.

Fig. 7. Pylon bottom joint connection (left) Column at axis C (right)

The columns of the bridge are concrete casted in forms with brick pattern. The columns are casted in steps with dimensions narrowing towards the top of the column. The columns at axis B and C support both the spans from both sides and the pylon towers and the column at axis D supports the spans from both sides. The abutments are located at the bridge edges on axis A and E. they are supporting the end spans. At axis A the abutment is a standalone element and it supports the ground behind it. At axis E the abutment is part of the anchorage chamber. The original drawing show the soil logs for four trial pits. At the area there is solid sandstone rock. The depth of the rock is marked in the drawing and is clearly seen on site. The foundations are shallow concrete foundations casted against and inside solid rock.

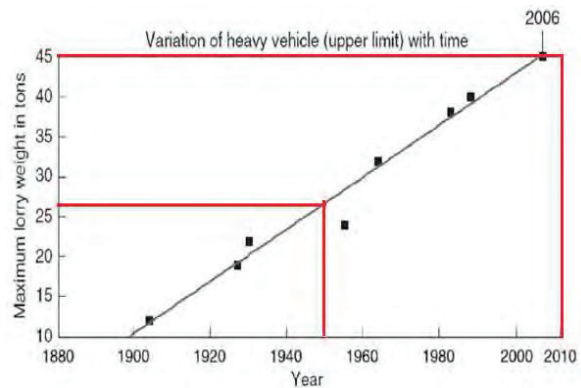
Fig. 8. Variation of heavy vehicle with time

According to this graph, the maximal truck load at the years of the bridge design and construction (1950') was approximately 26 tons. The maximal truck load representing the current time (2010') is approximately 45 tons. This represents a load increase of more than 70%. The live loads of the original design refer to the British standard 'BS153:1933'. The drawings of the bridge indicate the type of load used for the design including a load diagram and explanation. This represents a historical vehicle including a pulling lorry and carts.

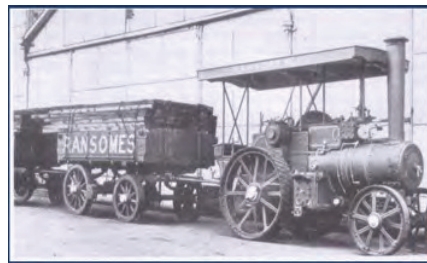
Fig. 8. A picture of the historical vehicle

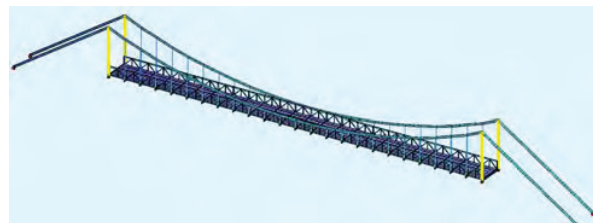
Fig. 9. FEM Model visualization (SOFiSTiK)

According to the capacity check we found that the beam withstands the original live load. In addition, the capacity of the transverse beam can cover the forces from a HA loading on one traffic lane or a HB load up to 80 tons as a single load on the bridge. The above section refers to a perfect condition bridge, which is not the current status. The Trusses are described in the geometry chapter. The Truss is the main support for the deck slab and is supported on sliding bearings on both sides.

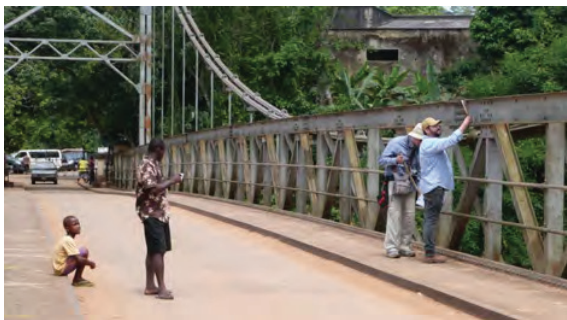
The inspection procedure included a visual non-destructive inspection and examination of the various elements. The bridge element condition was rated using different importance levels (from Low to Very High). This was performed and guided according to the procedures described in the next chapter. For the inspection of the bridge local workers were hired. In addition the team used the service of army security.

Fig. 10. Inspecting Trusses
