On the upgrade

Over 40 bridges in poor or dangerous structural condition are being renovated in Nigeria as part of improvements to highways connecting some of the country's major cities, including Lagos, writes **Micha B Petri**

Owner: Ministry of Works, Nigeria
Contractor: Reynolds Construction Company
Bridge consulting, rehabilitation and design: Kedmor Engineers

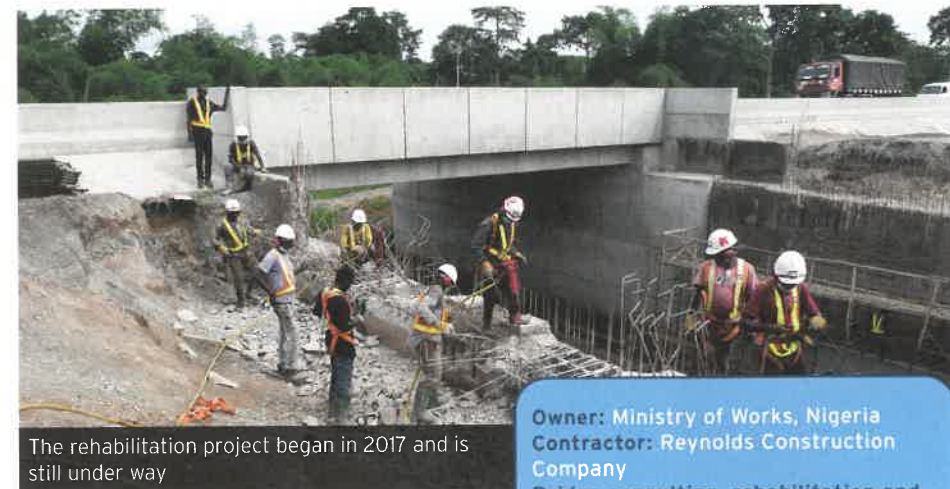
The rehabilitation project began in 2017 and is still under way

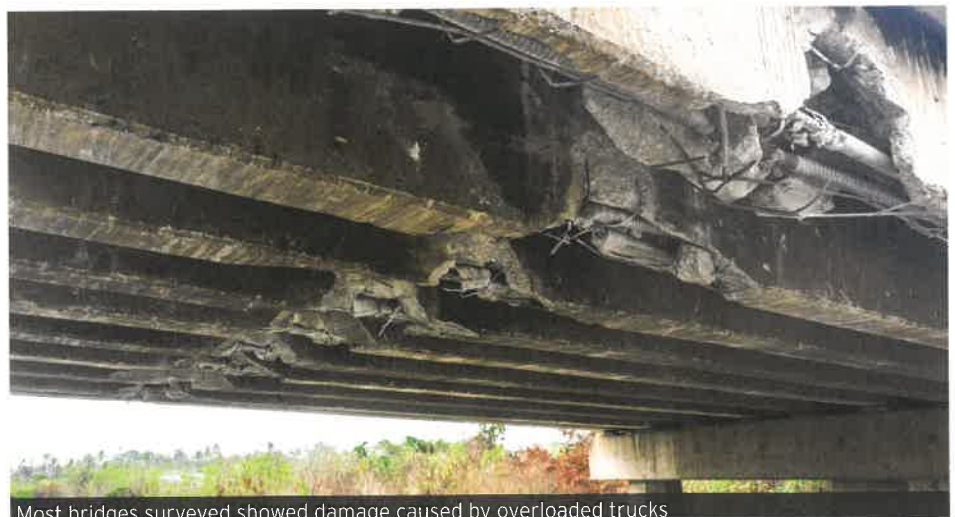
The traffic along the roads in the project is characterised by a large number of trucks that are sometimes loaded beyond their capacity, reaching 60t per truck in some cases, and with no control over the dimensions of the goods carried, in particular their heights. Bridges with varying clearance span the roadways, and bridge strikes are a frequent occurrence. In fact, the majority of the crossings surveyed showed damage to the beams facing the direction of oncoming traffic.

Most bridges surveyed showed damage caused by overloaded trucks

A typical intervention involves taking detailed measurement of the damaged bridge elements, as well as taking samples of concrete and reinforcing steel for analysis.

Damaged beams that require removal are also disassembled for inspection of the stressing cables so that the integrity of the bridge design can be assessed.
